Lea Castle: looking outwards

Lea Castle: Looking Outwards

Karen Dempsey

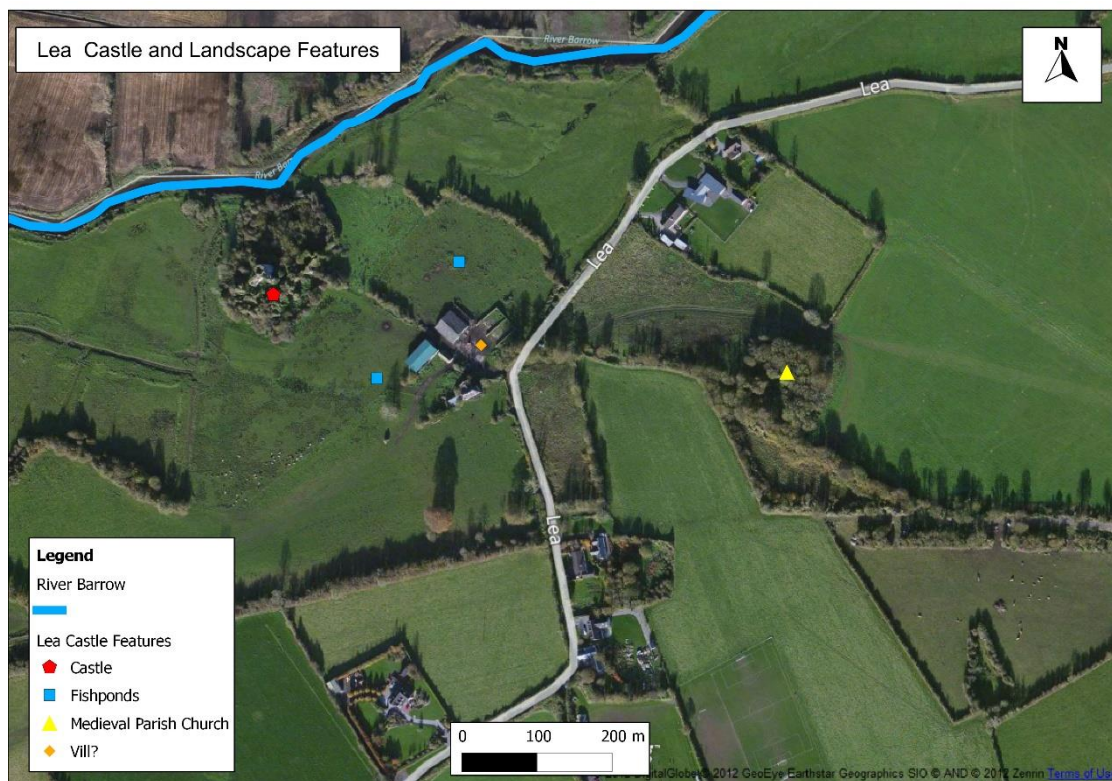
Fig. 1 - Lea Castle, Co. Laois: interpretative aerial image indicating the landscape arrangement and potential features. Photograph Karen Dempsey. Bing Images

The first completed in 2015, concentrated on the areas west, south and south-east of the castle, including the areas adjacent to the modern farmyard (fig 1). This revealed the return of the moat, over four depressions, both linear and sub-circular in shape that may be a series of interlinking fish-ponds and rectangular features which are interpreted here as possible house plots. However, all of these potential archaeological features are as yet unconfirmed. In 2016, the survey area was expanded to include a large field east and north east of the castle, which had some

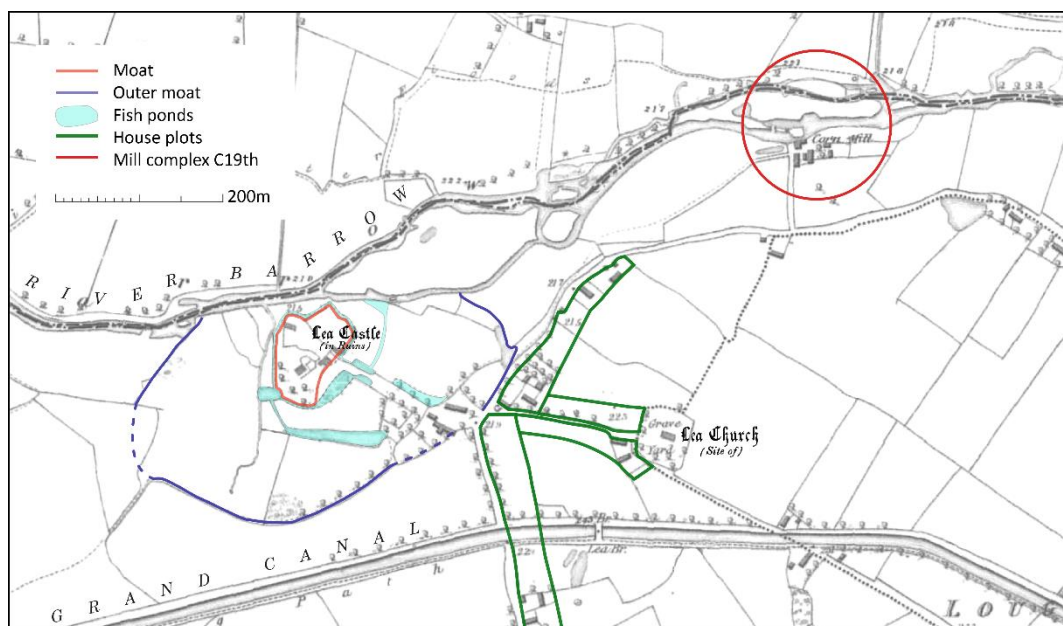
Fig. 2. Lea Castle, Co. Laois: interpretative image based on historic mapping exploring the potential medieval landscape. Source: First Edition Ordnance Survey mapping (1841). After Myles 2015; drawing K. Dempsey and C. McDermott.

Today, the landscape of Lea Castle is criss-crossed with modern drainage ditches; however, initial observations of the archaeological remains and study of the cartographic evidence, including an antiquarian plan from the 18th century, indicate evidence for an intricate waterscape which is re-imagined for this paper (fig 2).

Centrally placed within this landscape, traversing the putative moats and possible fish-ponds, a potential raised route-way may once have given access to and from the castle. Parallel field boundaries, only partially extant today but visible in historic mapping and noted on an antiquarian drawing represent this. Interestingly, it leads east-southeast towards the medieval church. It seems to create a physical link between the church and castle. Indeed, this could be read as a material statement of the ongoing, inseparable dialogue between the sacred and profane in the medieval world. The raised route-way terminates at the putative medieval *vill* beyond which further east is access to the church lane and medieval church (fig. 2).

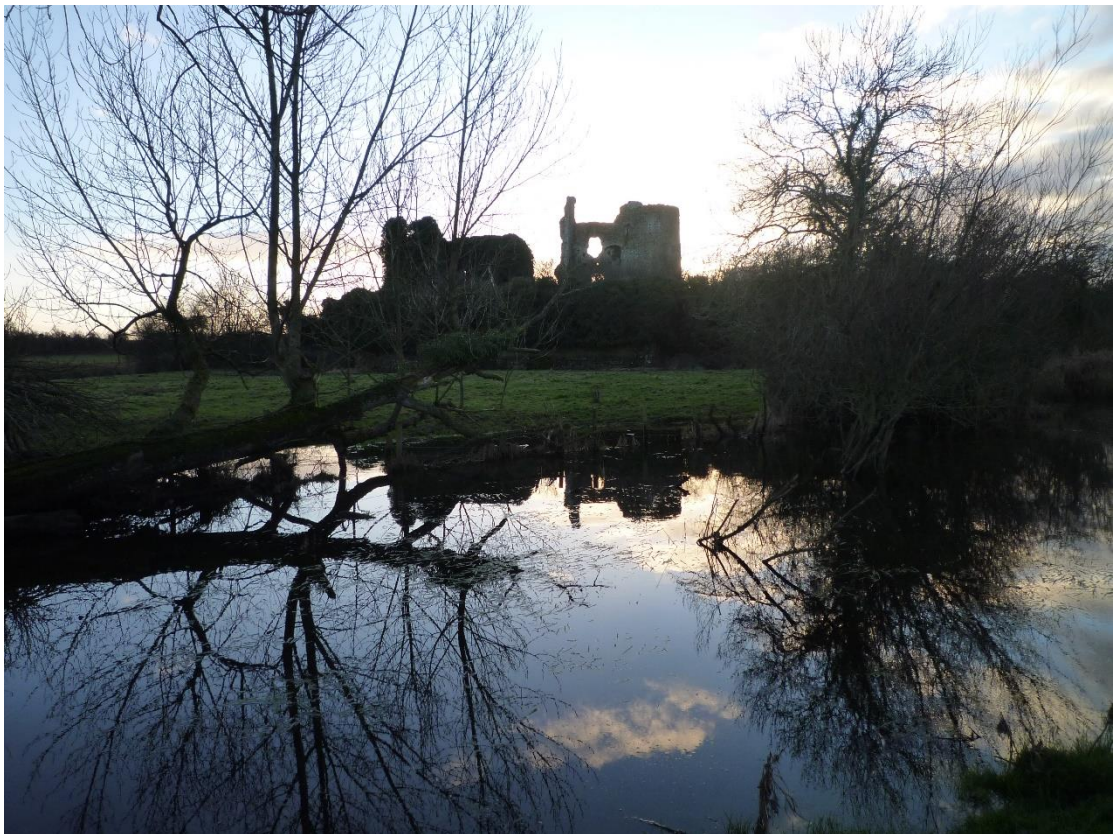
Fig. 3 - Lea Castle, Co. Laois: view across watery landscape facing west-northwest. Photograph Karen Dempsey.
